## SHUTTER BLANKS

DESIGNED TO HELP WINTERIZE  
FAN SHUTTERS

# SHUTTER BLANKS

## WINTERIZE FAN SHUTTERS WITHOUT REMOVAL

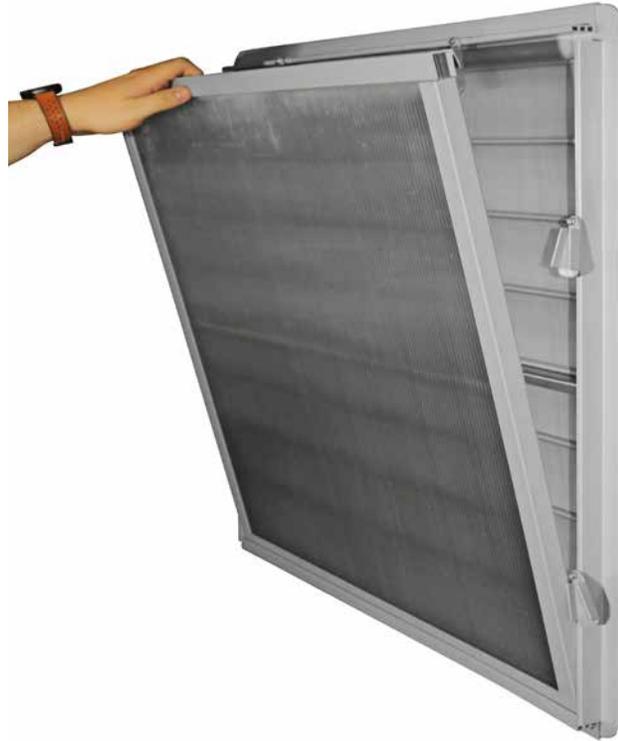
- › Simple and effective way to winterize fan shutters
- › Translucent panel allows natural light to enter the barn
- › Simple to install to reduce cold air leakage and heater run time

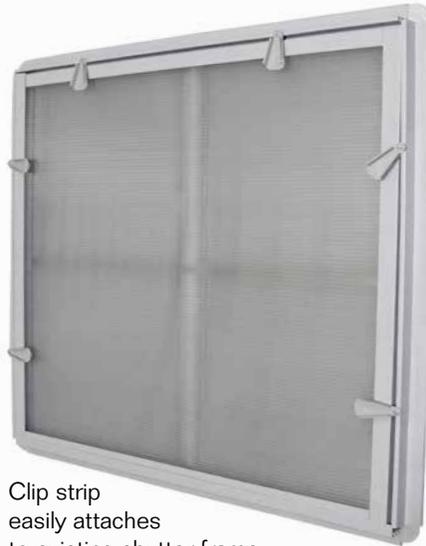
Clip strip easily attaches to existing shutter frame

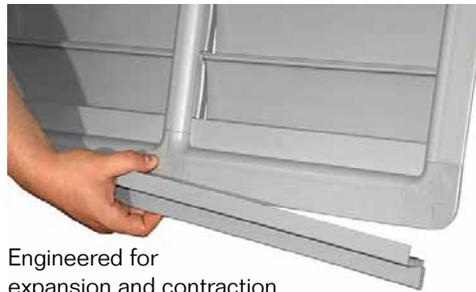
Flex Tip U-Channel with seal

Engineered for expansion and contraction

- > Panel is easy to store and light to handle in summer months
- > R-Value = R3 from multiple vanes in panel
- > Designed to work with a variety of fan shutters on the market
- > Flex Tip U-Channel pre-installed on panel helps prevent any water, dirt or air leakage
- > Engineered for expansion and contraction
- > Custom sizes available

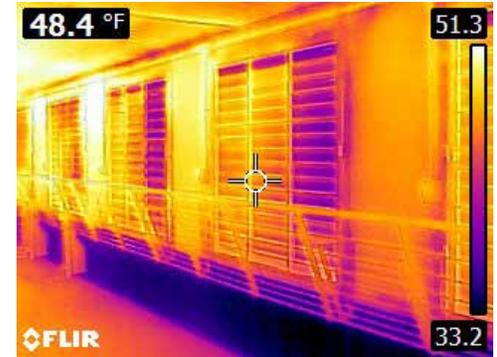
This forward looking infrared (FLIR) camera photo was taken at a 2,400 head finishing site in eastern Iowa when the outside temperature was below 0 °F (-17 °C). Here 54-inch (1372-mm) diameter fans are shown with cold air leakage coming into the facility. The leakage is indicated by the purple areas on the shutter front.

### FLIR Images of Before and After Use of Shutter Blank

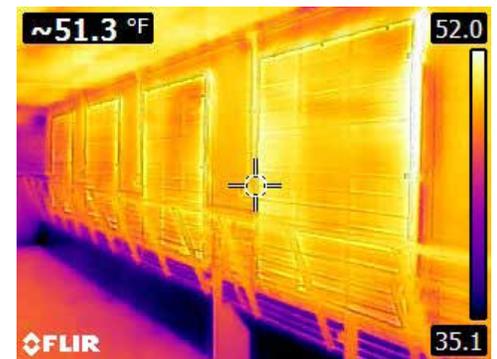
This FLIR photo was taken at the same finishing site in eastern Iowa 15 minutes after the PigTek Shutter Blank was installed on the 54-inch (1372-mm) fans. Note the reduction in cold air leakage and insulation provided on the fans as depicted by the uniform yellow/orange tones captured by the FLIR camera.
